Regain Services Pty Ltd

Capacity Increase at Tomago Spent Potlining Facility Hazard and Operability Study (HAZOP) Report 40,000 tpa Capacity Thermal Treatment Plant

DATE: 17 JANUARY 2020

REGAIN DOC NO.: 246R005

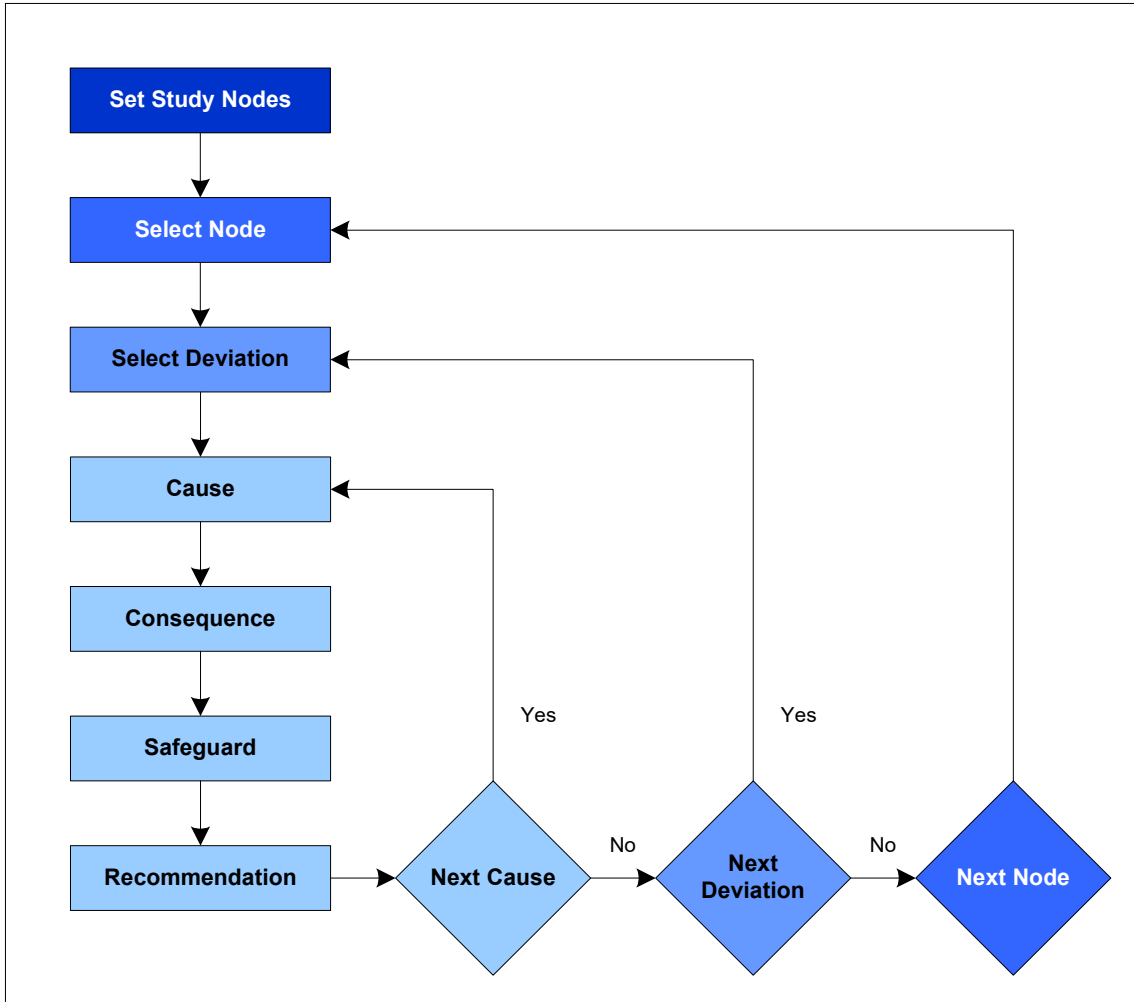
Figure 3.1 Hazop Technique

The Hazop followed the approach outlined in Figure 3.1. The Hazop nodes were determined by BV prior to the Hazop workshop during a review of the Piping and Instrumentation Diagram (PID) – Regain drawing number 246TD002 Revision H [1]. Additional nodes were identified during the workshop as required. Each node was assessed in detail by systematically considering deviations from normal operating conditions to identify hazard and operability issues. Causes, consequences, safeguards and any actions/recommendations were identified and recorded for each deviation.
